**Röwekamp, Marina**

## **Operating experience with hydrological external hazards and their potential safety significance**

natural external hazards, hydrological impact, nuclear power plant, operating experience

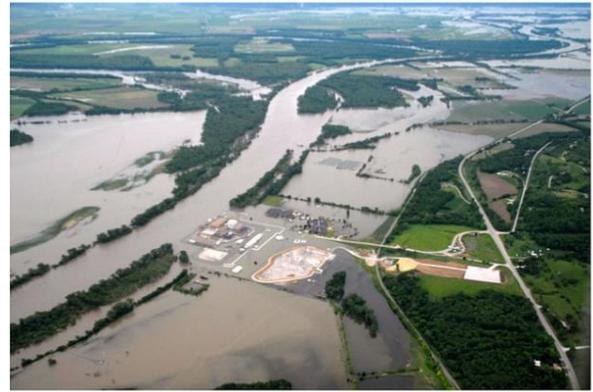
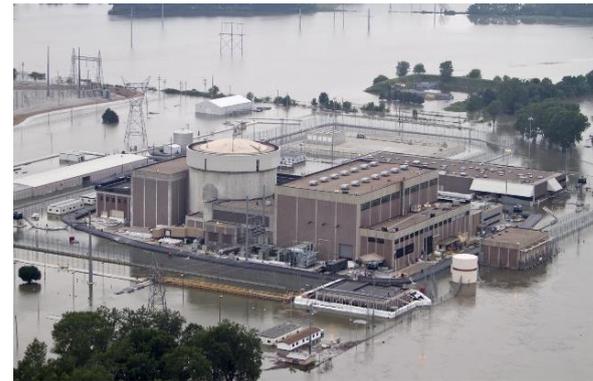
Figure 1. Fort Calhoun NPP site during the Missouri flood in 2011.

Fort Calhoun was designed for floods up to 1014 ft (309 m) above sea level. Berms and temporary AquaDams had been installed around Fort Calhoun's main plant buildings as well as the electrical switchyard and administration area.

On June 26, 2011 one part of an AquaDam suffered a puncture (attributed to work at the plant site) allowing

water to enter and to surround some of the plant buildings as well as the unit transformers. This prompted the staff to disconnect the plant from the offsite grid and to establish the energy supply of the plant safety systems from on-site diesel power by means of the diesel generators. This status remained until all the equipment checks confirmed that it was safe to terminate diesel power operation and to reconnect to the offsite grid. The NRC confirmed that cooling of safety relevant equipment was not impaired and that no water had entered the reactor building. Then, during the following weeks, the plant remained in safe shutdown throughout the event.

After the event the NRC inspection report concluded, that the protection strategy in the plant operating procedures would be insufficient to protect relevant plant facilities against an external flood of 1014 ft above sea level (design basis), which is an apparent violation of NRC requirements to be considered for enforcement action according to NRC Enforcement Policy.
