Baltic Sea port waters extreme events of last 30 years caused by climate-weather hazards

Abstract

The paper deals with the sea accidents that have occurred at the Baltic Sea port waters for last three decades. For each accident, the climate-weather change process state is fixed to examine the weather hazard influence on this accident. Moreover, the Baltic Sea port waters accidents caused by the extreme weather hazard states are described.

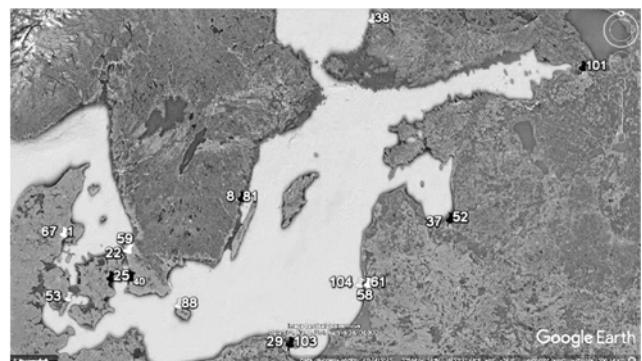
Figure 1. Ship accidents the Baltic Sea, port waters (the number on the map is corresponding to the accident number in Table 1 in [Bogalecka et al., 2017a]).

Despite the lack of exhausting, detailed and completed documents on ship accidents at the Baltic Sea for last three decades, we collected more than 100 sea accidents that have happened at the Baltic Sea area for last three decades [Bogalecka et al., 2017a]. A lot of them (81%) occurred at the Baltic Sea open waters [Bogalecka et al., 2017b]. The remaining accidents (19%) happened at the Baltic Sea ports (Figure 1).

The accidents that happened when the climate-weather change process was at the state c_4 and c_5 are marked with black pin on the map in Figure 1. We described these accidents in detail below.

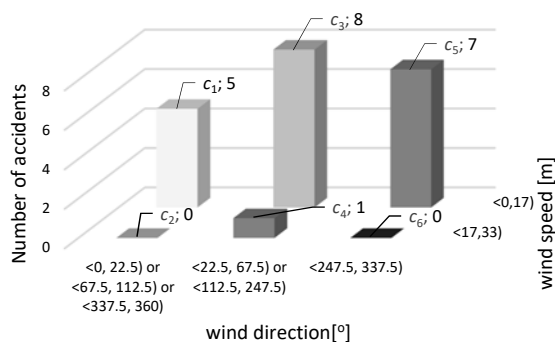
Figure 2. Number of the Baltic Sea port area accidents according to the states of the climate-weather change process.

In the compilation of accidents occurred at the Baltic Sea port areas there are 5 ones that happened when the climate-weather change process was at the state c_1 . In opposite, there are no accident that happened when climate-weather change process was at the state c_6 , means the extremely bad weather condition, but there are 1 and 7 accidents when the climate-weather change process was at the state c_4 or c_5 respectively, mean the moderate weather hazard states (Figure 2).

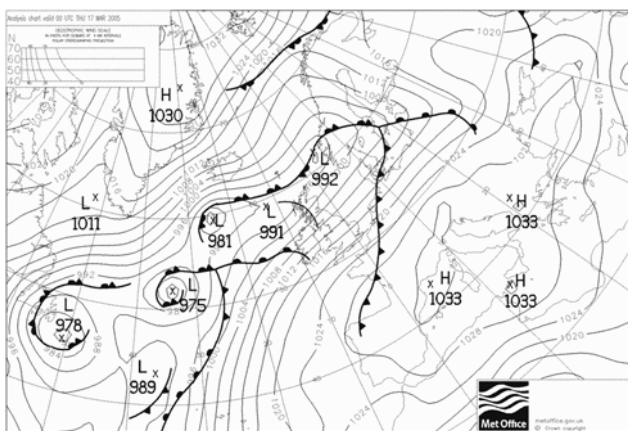
Figure 4. Synoptic map for Europe on March 17, 2005.

Over the Baltic Sea a trough of low pressure between Scotland and southern Norway was moving east. The previous day, the weather was influenced by a traveling warm front. The warmer part of the polar maritime air mass modified the weather at night. Whereas during the day the weather was subject to a cold front bringing a cooler polar maritime air mass (Figure 4). Despite the moderate weather hazard during the accident, the weather condition had the irrelevant influence on it.

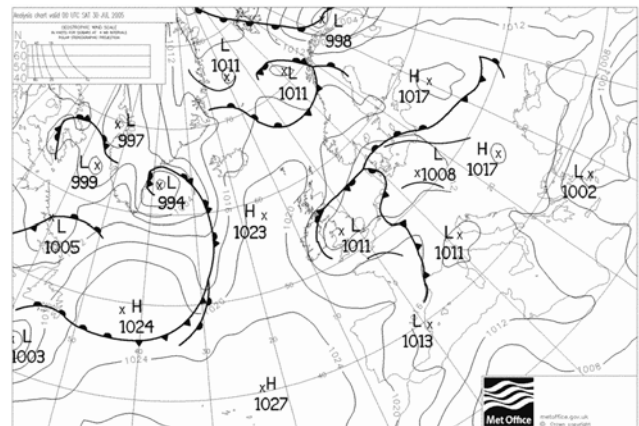
Figure 5. Synoptic map for Europe on July 30, 2005.

The Baltic Sea and northern Poland were influenced by a surface low pressure area originated over Denmark with a fronts system traveling east and

northeast. Warm part of the low pressure area stagnating at night over Poland contained a warm, moist and unbalanced air mass (Figure 5).

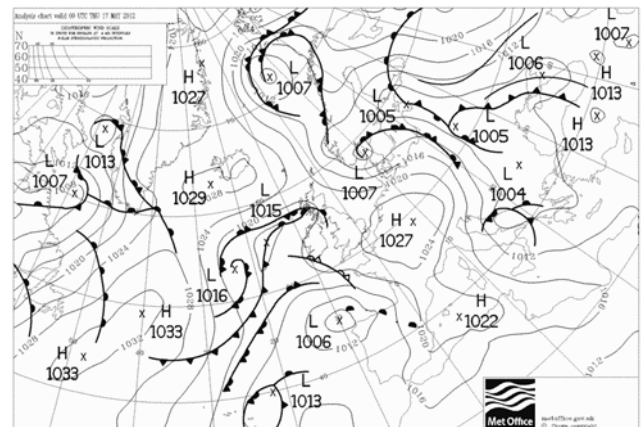
Figure 10. Synoptic map for Europe on May 17, 2012.

The trough of low pressure area was deepening and moving north along with the fronts system from southern Scandinavia and the North Baltic Sea. An area of high pressure was moving eastwards. A polar maritime air mass was approaching from the North Sea (Figure 10).
